782 MAIN STREET

INTERNATIONAL HARVESTER BUILDING

City of Winnipeg Historical Buildings & Resources Committee Researcher: M. Peterson December 2017 This building embodies the following heritage values as described in the *Historical Resources By-law*, 55/2014 (consolidated update July 13, 2016):

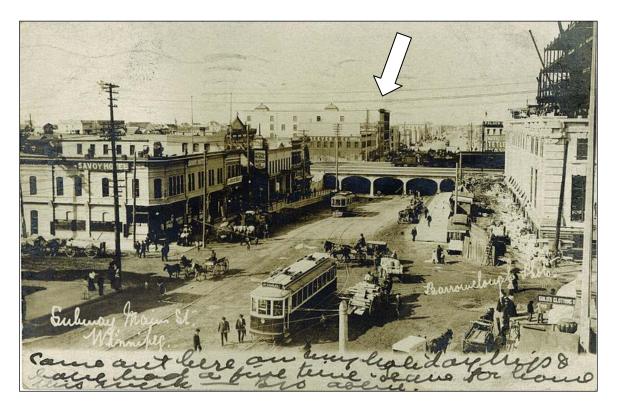
Plate 4 – Postcard of Main Street looking north from Higgins Avenue, ca.1905. The Royal Alexandra Hotel is being completed on the right side of the image; the International Harvester Building is in the background (arrow). (<u>Reproduced from Peel's Prairie Provinces, University of Alberta Libraries, Postcard 1422</u>.)

Another important aspect of the rail development in the area was the construction of the Main Street railway subway at Higgins Avenue, started in May of 1902 and officially opened in early 1905 (Plate 4). This structure alleviated the congestion caused by the dozens of daily passenger and freight trains using the level crossing of the eight rail lines running east-west into and out of the CPR yards and halting the ever-increasing vehicular and pedestrian traffic on Main Street.

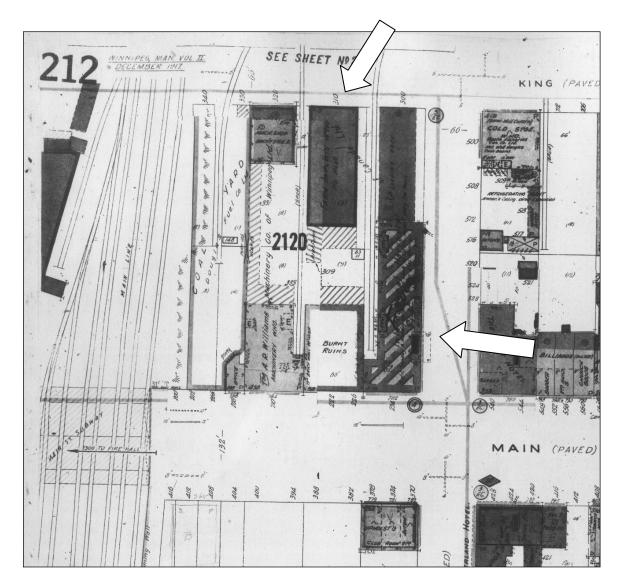
Plate 5 – <u>Fire Altas, City of Winnipeg</u>, Vol. II, Sheet 212 (December 1917). The International Harvester Building (right arrow) includes a large loading dock to the rear, a large, unheated storage building to the south (top arrow), platforms and two spur lines. (<u>City of</u> <u>Winnipeg</u>.)

The same could be said for the north side of the CPR line, where new warehouses were built to take advantage of the excellent connections. In 1904, one of the largest warehouses in the area was completed for a large agricultural machinery firm just north of the CPR subway on the west side of Main Street and connected to the CPR through spur lines (Plates 5 and 6).

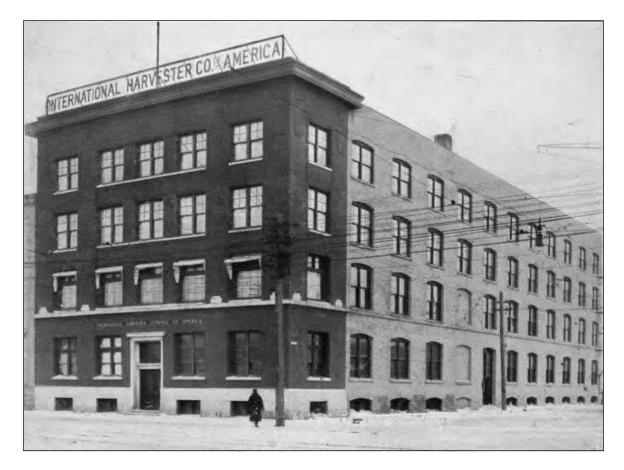
Plate 6 – International Harvester Building, 782 Main Street, 1909. (<u>Reproduced from</u> <u>International Harvester Company Annual Report – 1909, p. 43</u>.)

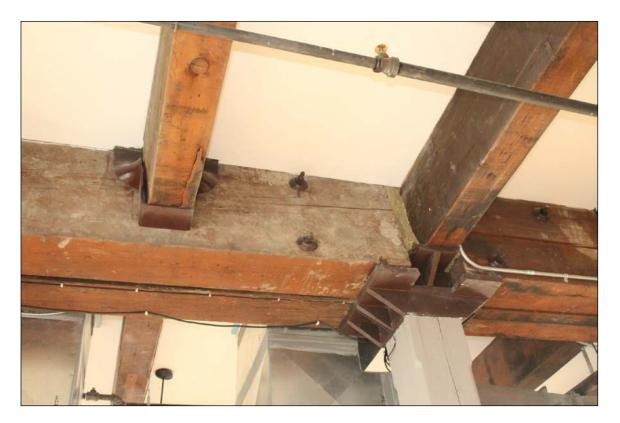
Plate 7 – International Harvester Building, 782 Main Street, example of double beam construction, 2017. (<u>M. Peterson, 2017</u>.)

While the International Harvester Building is one of many mill construction structures in the Exchange District, it features a number of unique elements, including large, double wood beams (Plate 7) and unique metal beam hangers (Plate 8). These elements and others were utilized to ensure the building could handle the weight of the materials stored in it.

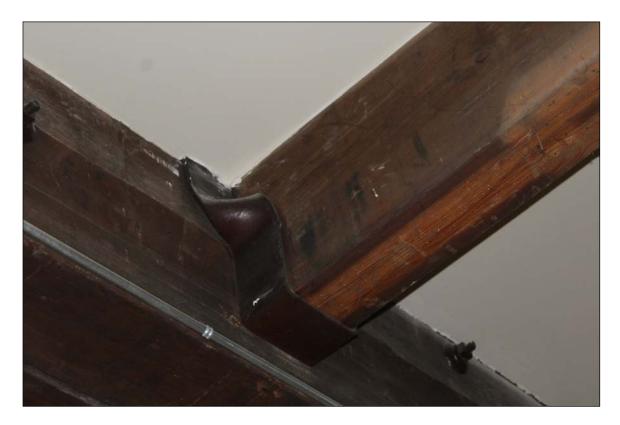
Plate 8 – International Harvester Building, 782 Main Street, example of ornate, curved beam hanger, 2017. (<u>M. Peterson, 2017</u>.)

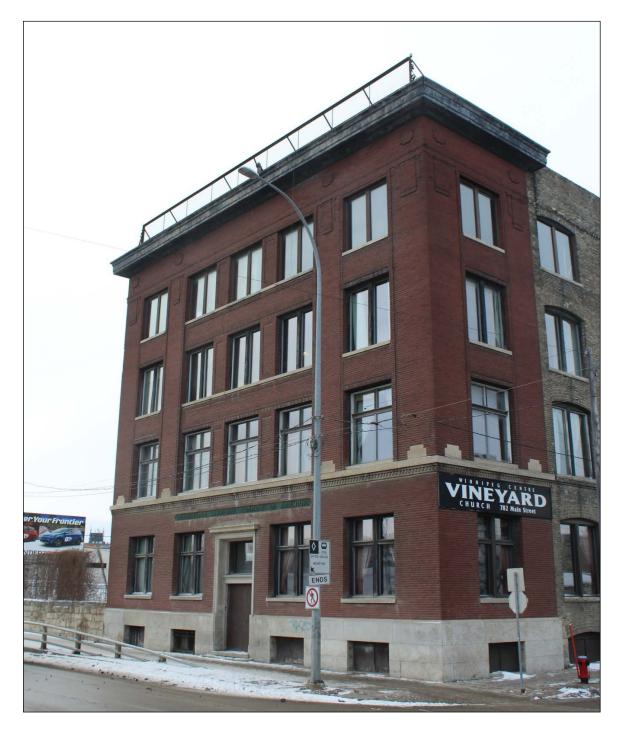
Plate 9 – International Harvester Building, 782 Main Street, front (east) façade, 2017. (<u>M. Peterson, 2017</u>.)

The front (east) façade is finished in dark brick; limestone is used as accenting at grade and around windows and doors (Plate 9). The raised basement wall is clad in smooth-cut limestone, interrupted by small rectangular basement windows. Smooth-cut stone is also used as a modest frame around the centrally located entrance. Large square headed window openings fill the remainder of the ground floor and are embellished with stone lug sills. A sign with the words "INTERNATIONAL HARVESTER COMPANY OF AMERICA" is found above the entrance and the level is finished by a modest stone belt course with brick accenting (Plate 10). The upper three floors are divided into three bays by wide pilasters with small stone accents at their bases and ornamental brickwork at their heads. The outer two bays hold rectangular window openings with stone sills and brick heads, the middle bay holds three rectangular window openings connected by continuous stone sills and brick heads. A wide band of brick above the fourth floor window openings lead to the heavy overhanging metal cornice finishes the façade. The original metal sign fence is still present (Plate 11) but the original flagpole has been removed.

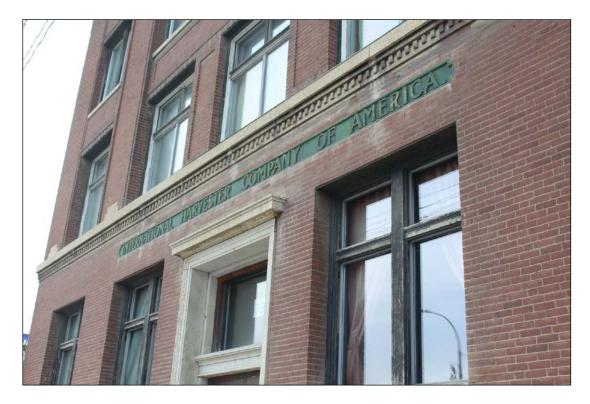
Plate 10 – International Harvester Building, 782 Main Street, detail of front (east) façade, 2017. (<u>M. Peterson, 2017</u>.)

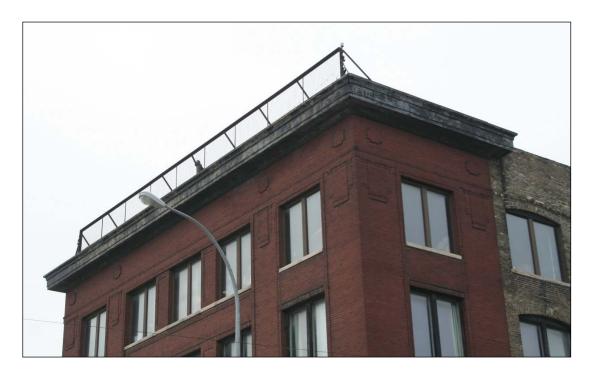
Plate 11 – International Harvester Building, 782 Main Street, detail of front (east) façade, 2015. (<u>M. Peterson, 2015</u>.)

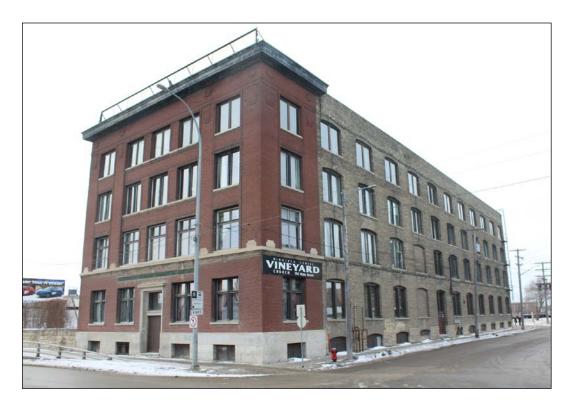
Plate 12 – International Harvester Building, 782 Main Street, front (east) and north façades, 2017. (<u>M. Peterson, 2017</u>.)

The north façade, beyond the front bay, is completed in common clay brick; large arched window openings are found on all floors (including smaller basement openings). An entrance is located near the centre of the façade and two openings to the east on the first and second floor have been bricked in since construction (Plate 12).

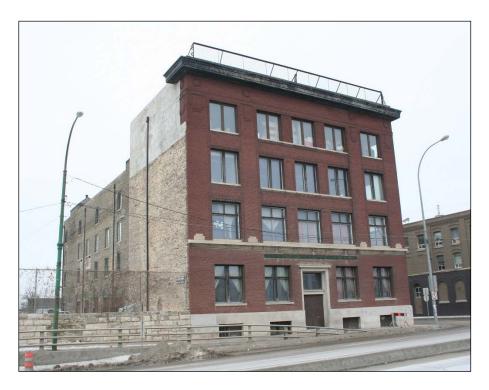
Plate 13 – International Harvester Building, 782 Main Street, front (east) and south façades, 2015. (<u>M. Peterson, 2015</u>.)

The south façade is built of common clay brick, the windowless front section extends out (Plate 13). To the west, a set of large loading doors fill the ground floor and all upper floors feature

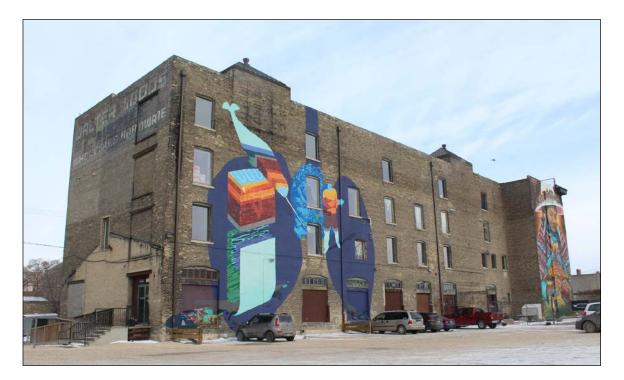
Plate 14 – International Harvester Building, 782 Main Street, rear (west) and south façades, 2017. (<u>M. Peterson, 2017</u>.)

small arched window openings (Plate 14). Raised metal roofs are found above the elevator shaft and stairwell on the south side of the flat roof. Two murals have been painted on this façade.

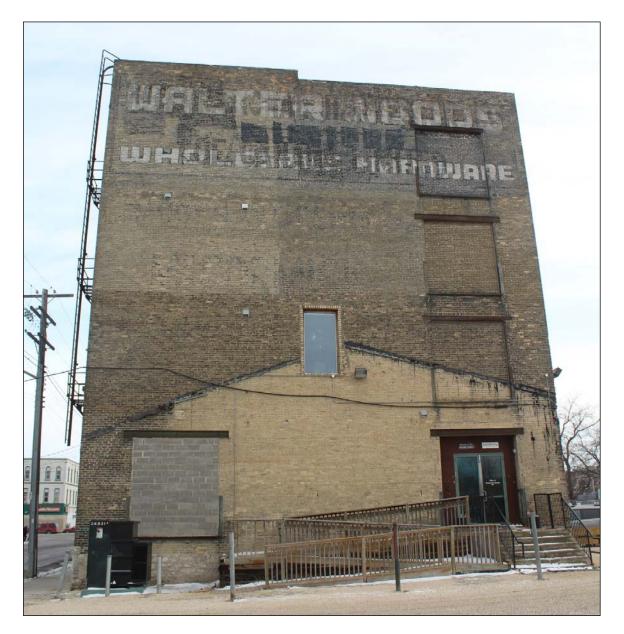
Plate 15 – International Harvester Building, 782 Main Street, rear (west) façade, 2017. (<u>M. Peterson, 2017</u>.)

The rear (west) façade features large rectilinear openings with metal lintels at the south end of each floor, the upper three openings have been bricked in, the ground floor opening has been partially filled and now holds a newer raised entrance with ramp (Plate 15). Another similar opening is found at north end of the ground floor and it too is closed in. The outline of the one-storey rear building is visible, as is painted signage at the roofline.

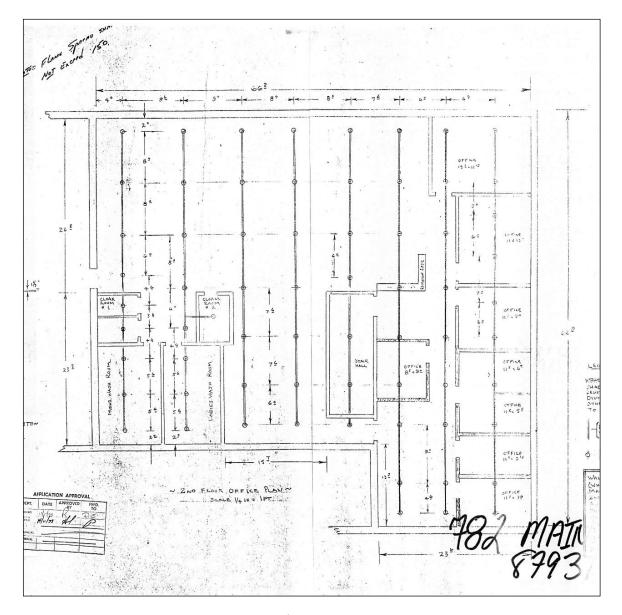
Plate 14 – Architect's plans, alterations to 2nd floor office space, 1973. (<u>City of Winnipeg, Plan</u> #8793/1973.)

In 1971, alterations were made to the shipping office,⁷ in 1973, second floor offices were altered⁸ and again in 1993 (Plate 14).

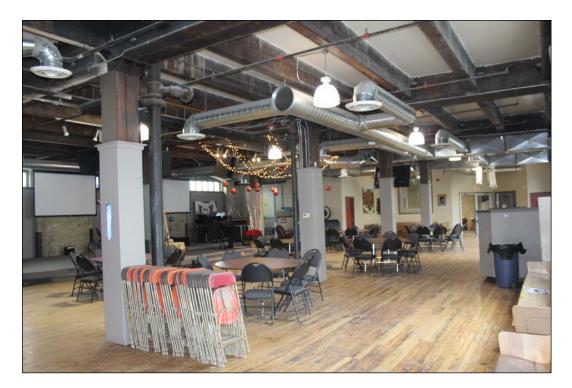
Plate 15 – International Harvester Building, 782 Main Street, main floor, west end, worship/meeting space, 2017. (<u>M. Peterson, 2017</u>.)

The building's conversion to a church has necessitated major interior renovations. The basement remains open and used for storage, the main floor includes worship/meeting spaces in the east and west ends and offices in the centre (Plates 15 and 16). The second floor includes more church space as well as residential space for transitional housing with common eating and recreational areas

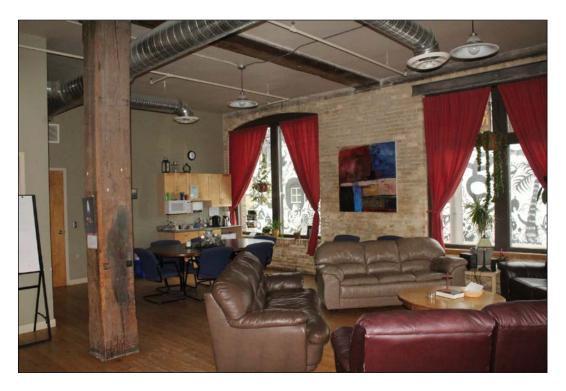
Plate 16 – International Harvester Building, 782 Main Street, east end, first floor meeting area, 2017. (<u>M. Peterson, 2017</u>.)

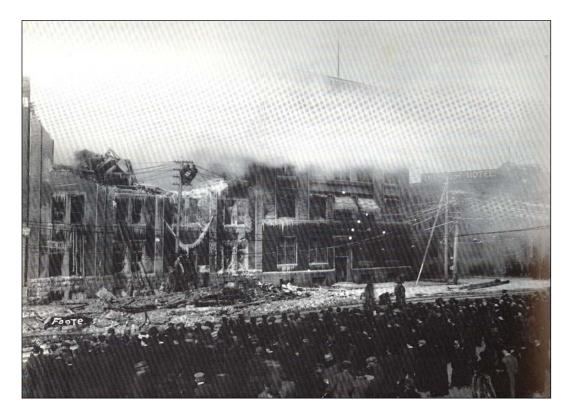
Plate 26 – Aftermath of the March 9, 1912 Radford-Wright Building fire. Partially obscured by the smoke is the International Harvester Building to the right. (<u>Reproduced from V.</u> Leah, Alarm of Fire, [Winnipeg, MB: Firefighters Burn Fund, 1982], p. 64.)

On March 9, 1912, a deliberately set fire at the Radford-Wright Sash and Door Factory (immediately south of this building) led to an explosion of two chemical vats, totally destroying the Radford-Wright Building, seriously damaging the International Harvester Building and killing two firefighters (the first ever in Winnipeg in the line of duty) and eight spectators (Plates 26 and 27).¹⁵

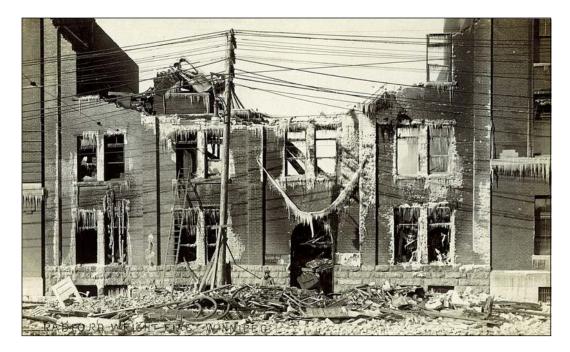
Plate 27 – Postcard of the aftermath of the Radford-Wright Building fire, 1912. The International Harvester Building is to the right. (<u>Reproduced from Peel's Prairie</u> <u>Provinces, University of Alberta Libraries, Postcard 1275</u>.)
